# Placing Antifreeze Concrete at Grand Forks Air Force Base

Charles Korhonen and Peter Semen

April 2005

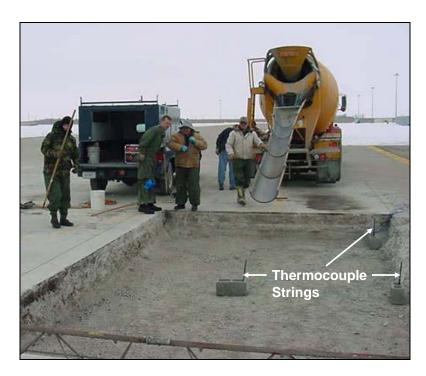
Figure 2. Repair section instrumented with thermocouples.

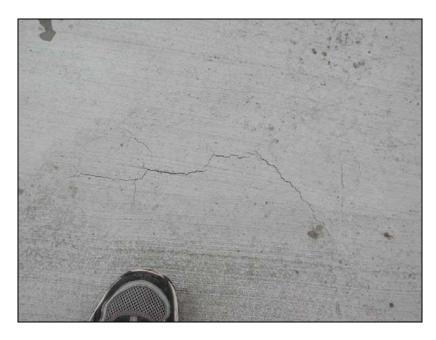
mm thick, dropped approximately 26°C in the 24 hours after the insulation was removed. As would probably occur for any concrete structure, the slab cracked (Fig. 13). In fact, we believe that it cracked during our inspection between 8:00 and 9:00 a.m. the morning following concrete placement, about 3 hours after the insulation was removed. The crack could probably have been avoided if the insulation had been left in place another day.

Figure 13. Crack that developed in the concrete approximately 3 hours after the insulation blanket was removed.
